# The discovery of the Globe Theatre

Simon McCudden

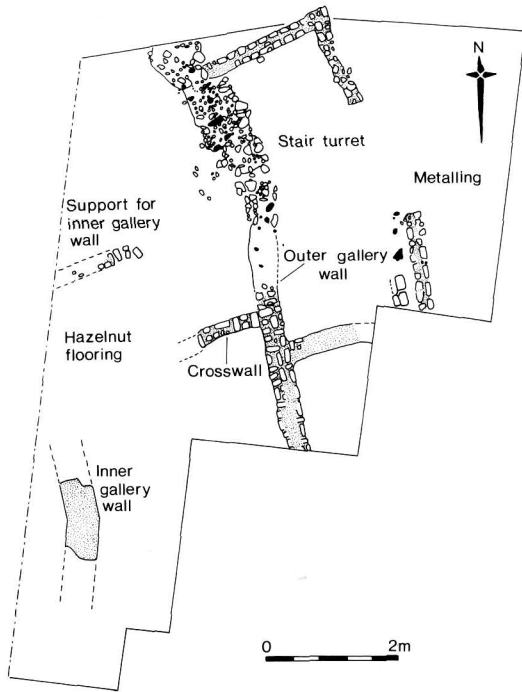
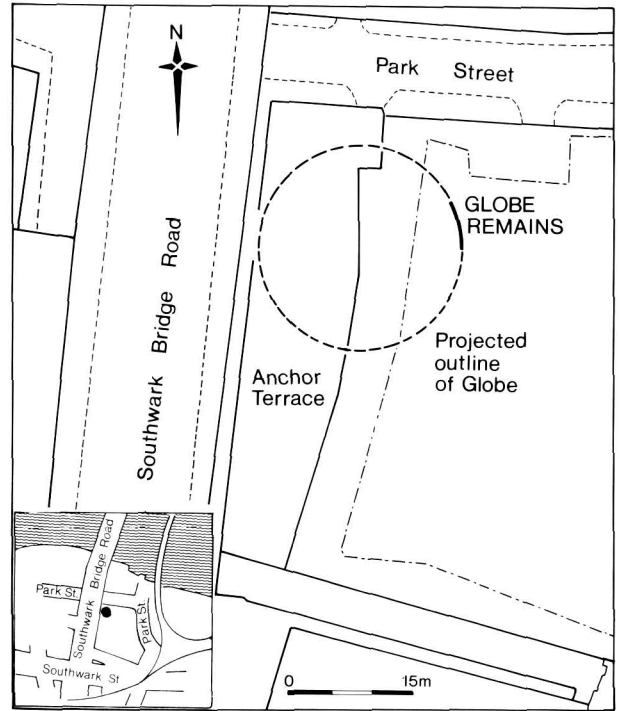
Fig. 1: (left) plan of the Globe Theatre remains; (right) site location plan, showing the projected extent of the Globe Theatre remains.

Only a fraction of the Globe – approximately 12m × 9m (40ft × 30ft) – has been found (Fig. 1). The part uncovered appears to be in the north-east section of the theatre, and comprises three parallel wall foundations, two of brick and one of chalk and timber.

The central chalk and timber foundation, which is of a solid, mortared construction, would have supported the outer gallery wall of the first theatre. No trace of the inner gallery wall of the earlier theatre has been found, but a short length of the substantial brick and mortar foundation for the inner gallery wall of the second survives.

The bottom brick course of the outer gallery wall of the second Globe supported on the foundation for the first outer wall. Brick crosswalls added at the time of the construction of the later theatre extend to the east and link with other brick walls, which may well belong to an outside staircase/turret. The gap in the easternmost wall may be an entrance to the theatre.

The dimensions of the theatre are very difficult to establish because only a small area has been uncovered. The presence of angles within the three main walls and the fact that they are running parallel to each other suggests that the shape of the structure was polygonal. The question of how many sides remain is unresolved, but a computer projection along the chalk and mortar foundation suggests that the diameter of the theatre was between 64 and 80 ft (19 and 25m). A diameter of 80 ft is shown on the projected outline on Fig. 1 (right).

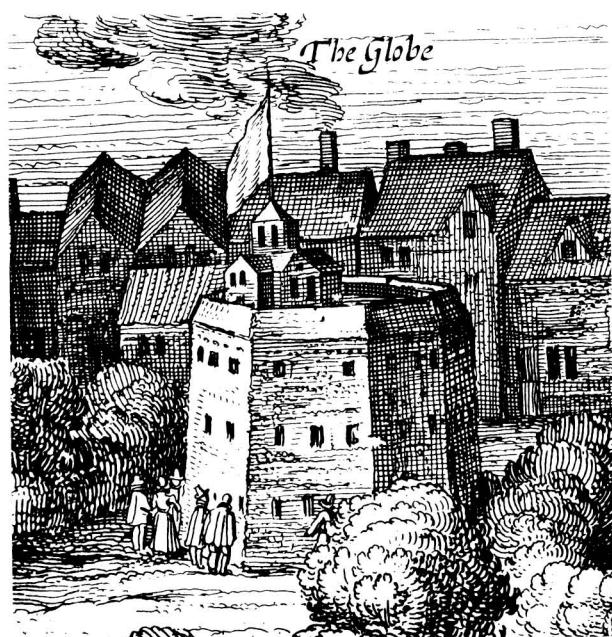
Fig. 2: the Globe Theatre by C J Visscher (1616).

“this wooden O” in the prologue to Shakespeare’s *Henry V*. C J Visscher’s view, published in 1616, shows a three-storey gallery, octagonal in shape and sloping inwards from the top (Fig. 2). A later view by Wenceslas Hollar published in 1647, though drawn in 1630, shows a squat, circular theatre.
